Final Testing and Completion Report (SV3)

Site Walk Date: 2014-12-22

Home	Builder	Model
801 3rd St SE	Habitat for Humanity - Rochester Area	Production
Kasson, MN 55944	1530 Greenview Drive SW Suite 107 Rochester, MN 55902	Type: Single-family detached Size: 1881 ft ²

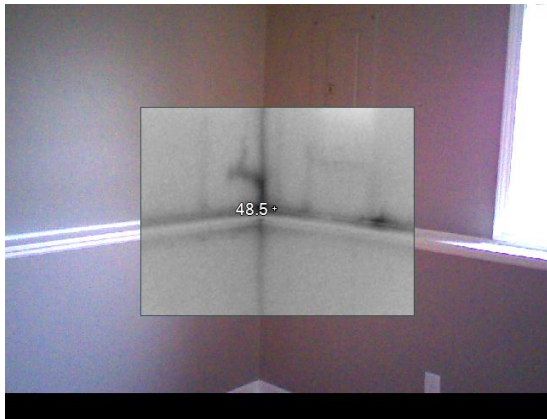
Figure 1.1

Air leakage pathways

Unintentional air leakage pathways can result in unconditioned air moving through enclosed building cavities leading to reduced insulation effective R-value, building durability, uneven interior surface temperatures, structural air leakage, occupant discomfort, and high utility costs. Apply solid drafts top or foam/caulk gaps and penetrations to seal potential pathways at the framing stage.

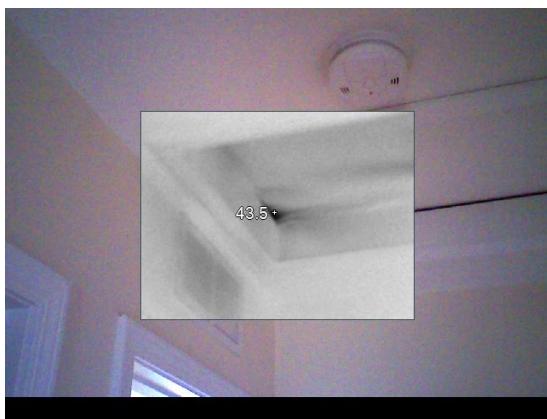
Figure 2.1

Attic hatch leakage

Leakage at the attic access can lead to durability issues, uneven interior surface temperatures, occupant discomfort, and high utility costs. Install an insulated hatch that is fully gasketed or sealed in place.
