Orness Plaza

Building Commons – Atrium Final Results

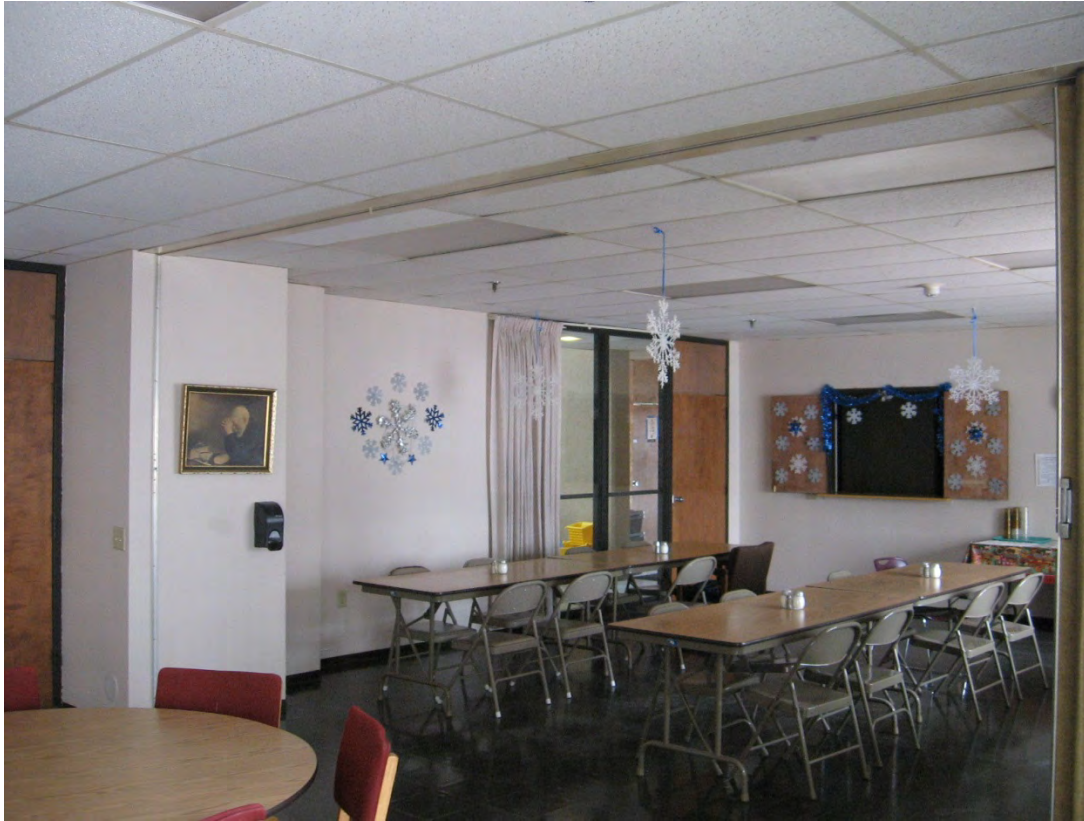
Building Commons – Community Room Before Construction

Cool colors
Closed kitchen
Dated materials

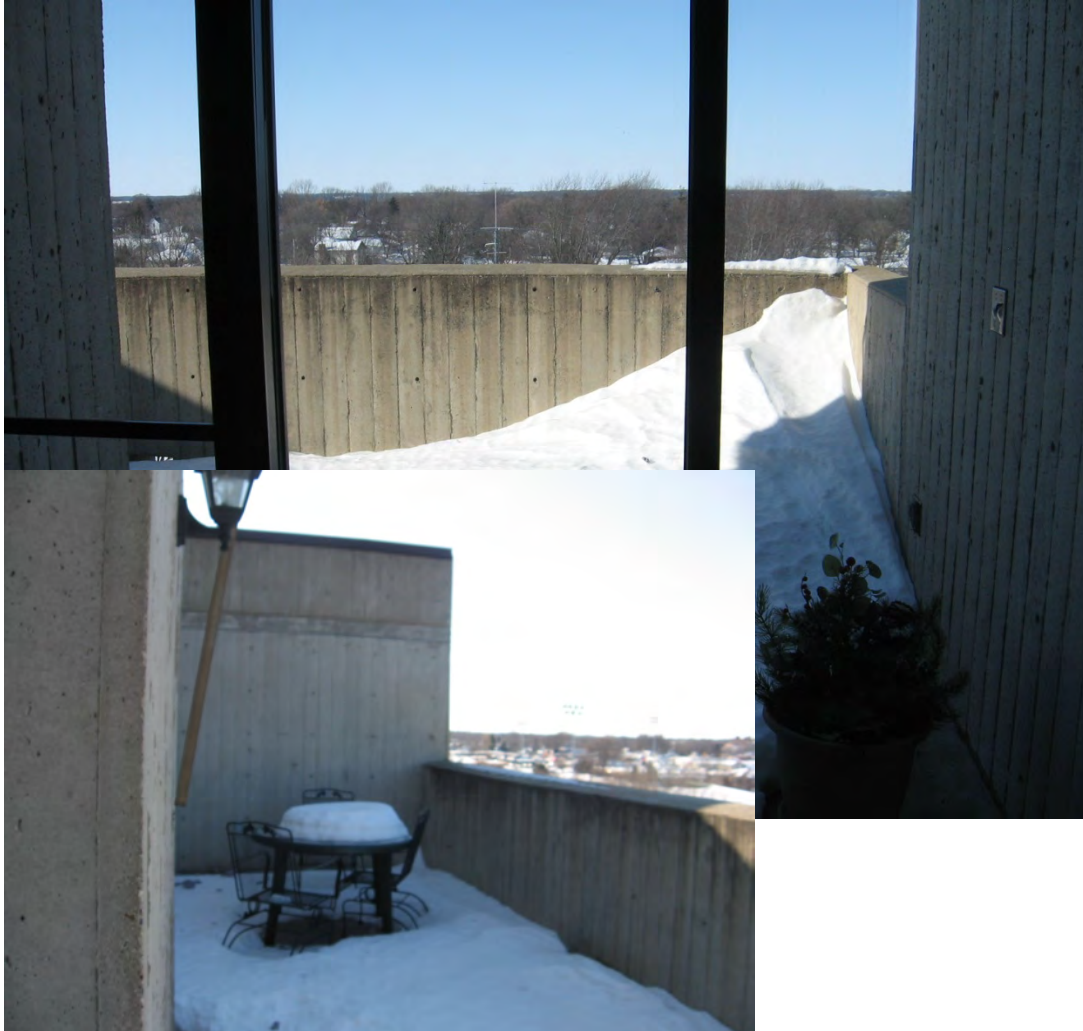
Building Commons – Balconies Before Construction

Three balconies

Exterior

7th floor open to sky

Unused during cooler months

Uninviting

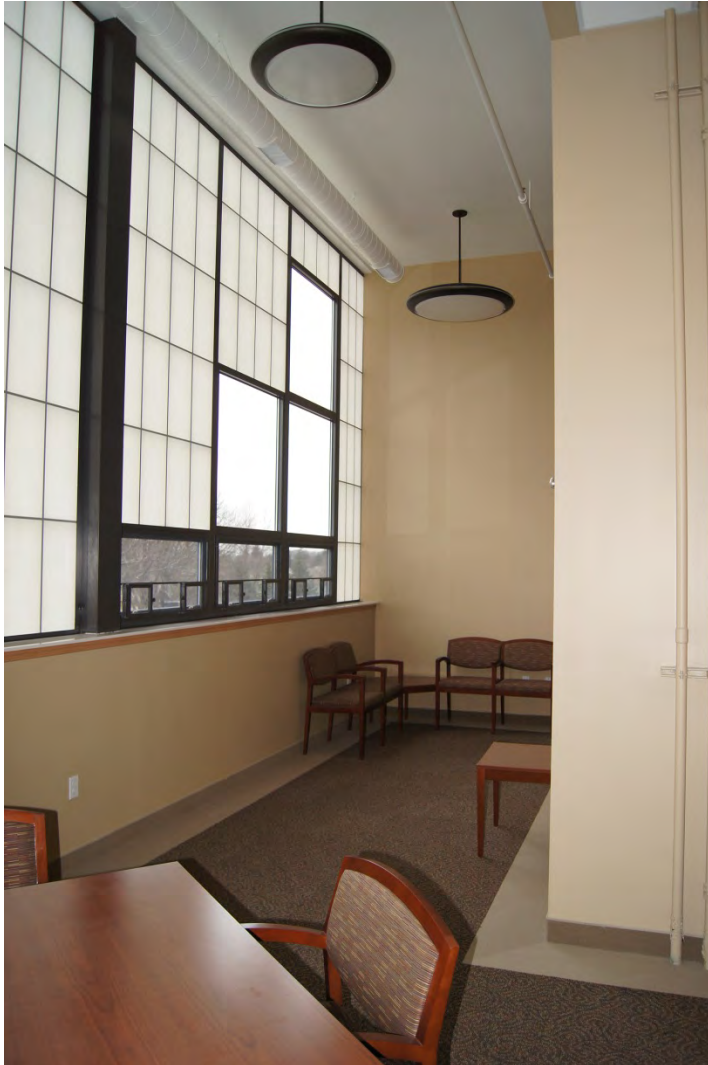
Building Commons – Balconies During & After Construction

Added roof at 7th floor

Enclosed all spaces

Included filtered light,
but with views

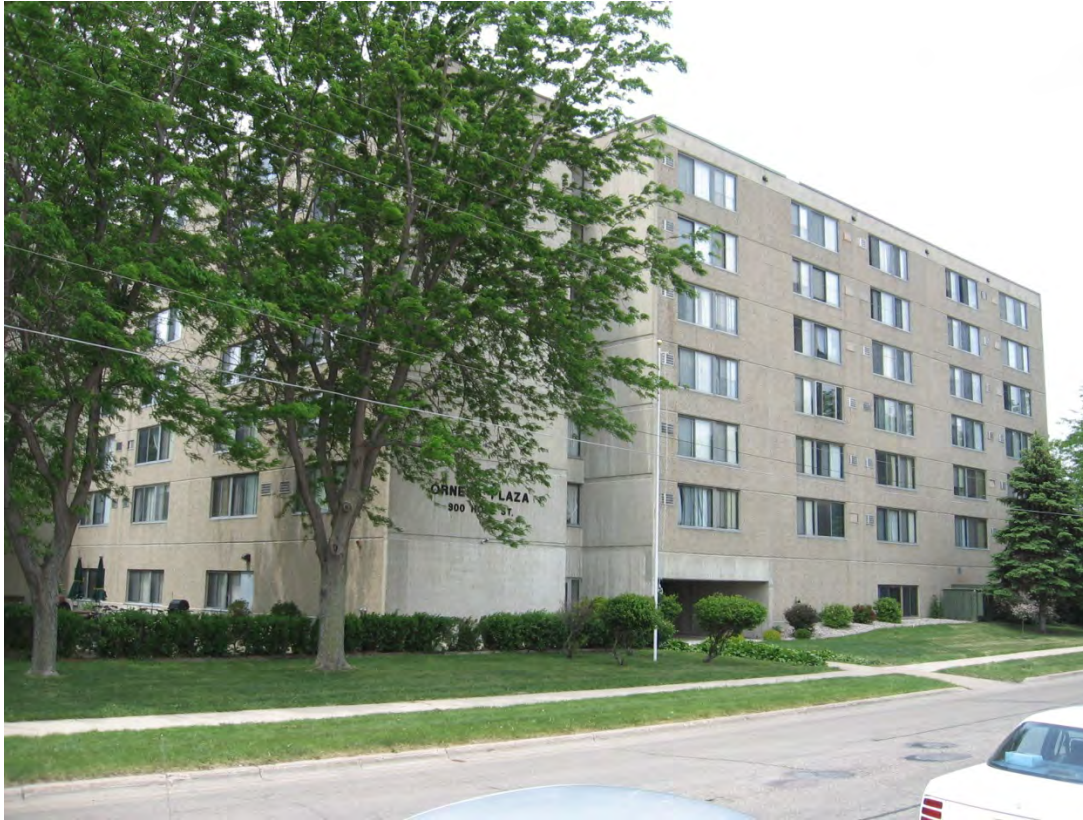
Exterior– Building Façade Before Construction

Gray, gray, &
more gray

Discolored

Some textural
variation, but
nothing eye
catching

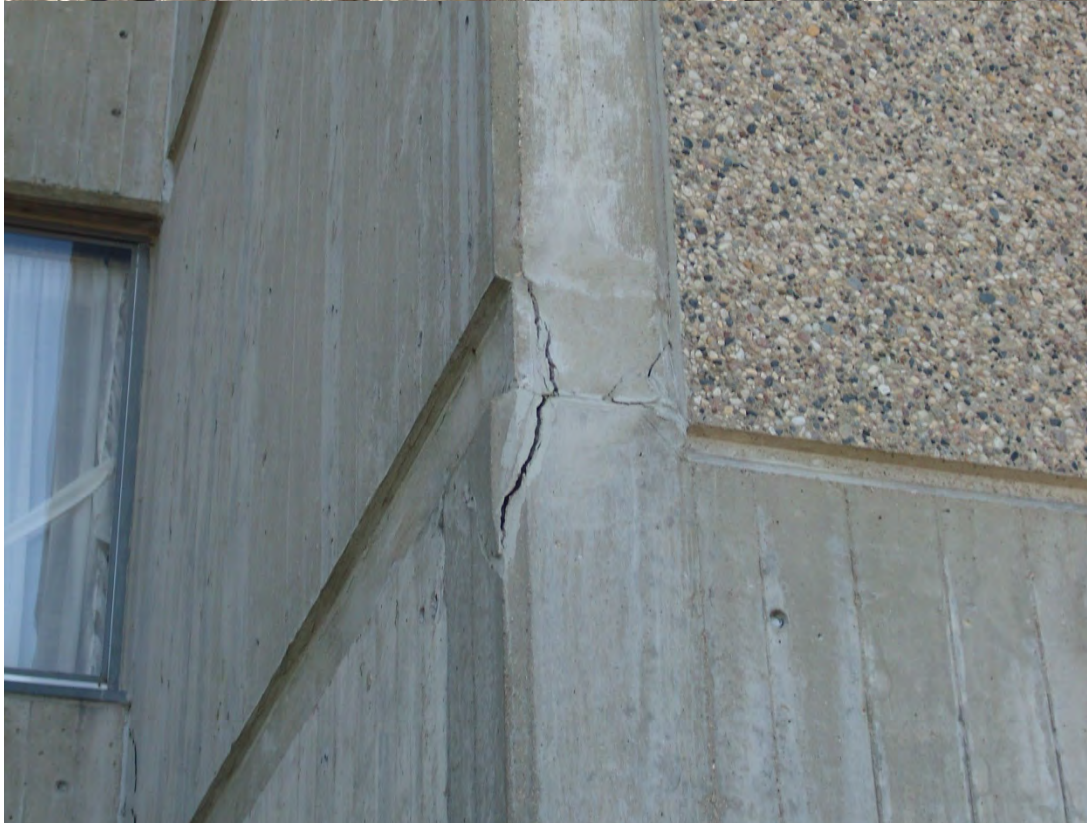
Exterior– Building Façade Cracks & Leaks

Various cracks

Non-structural

Leaking

Delaminating

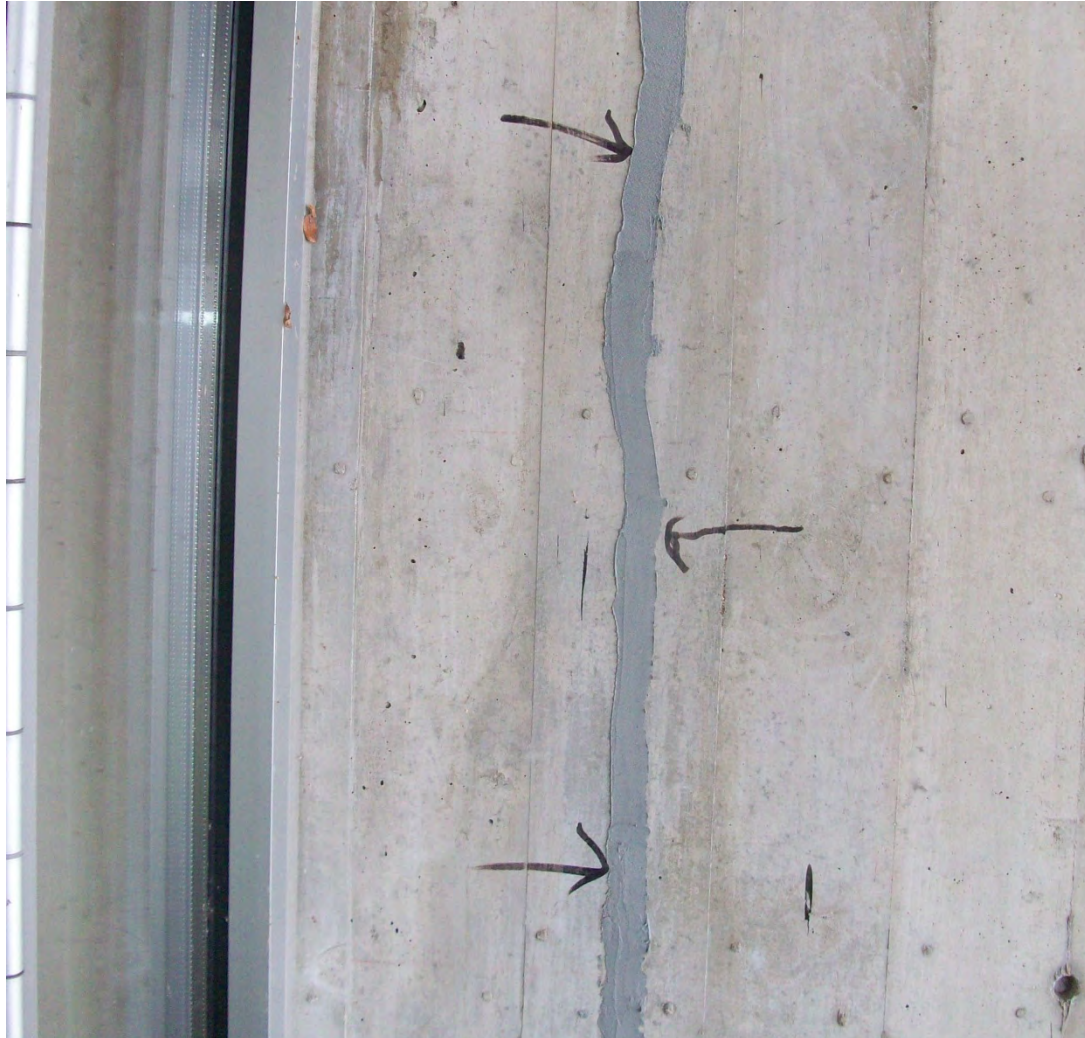
Exterior– Building Façade Cracks & Leaks

Identifying
trouble locations

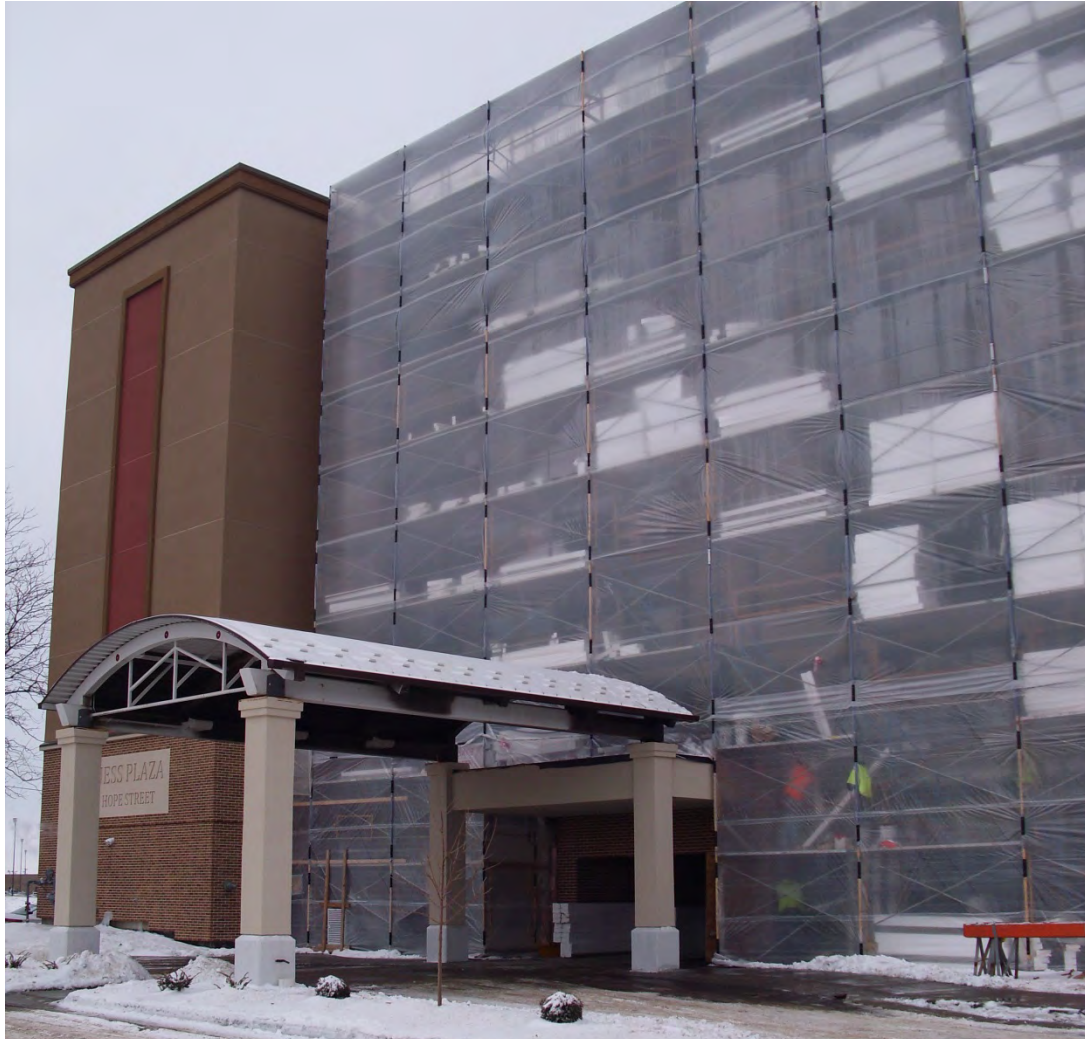
Exterior– Building Façade During Construction

Scaffolding

Winter
protection

Insulation

Finish coat

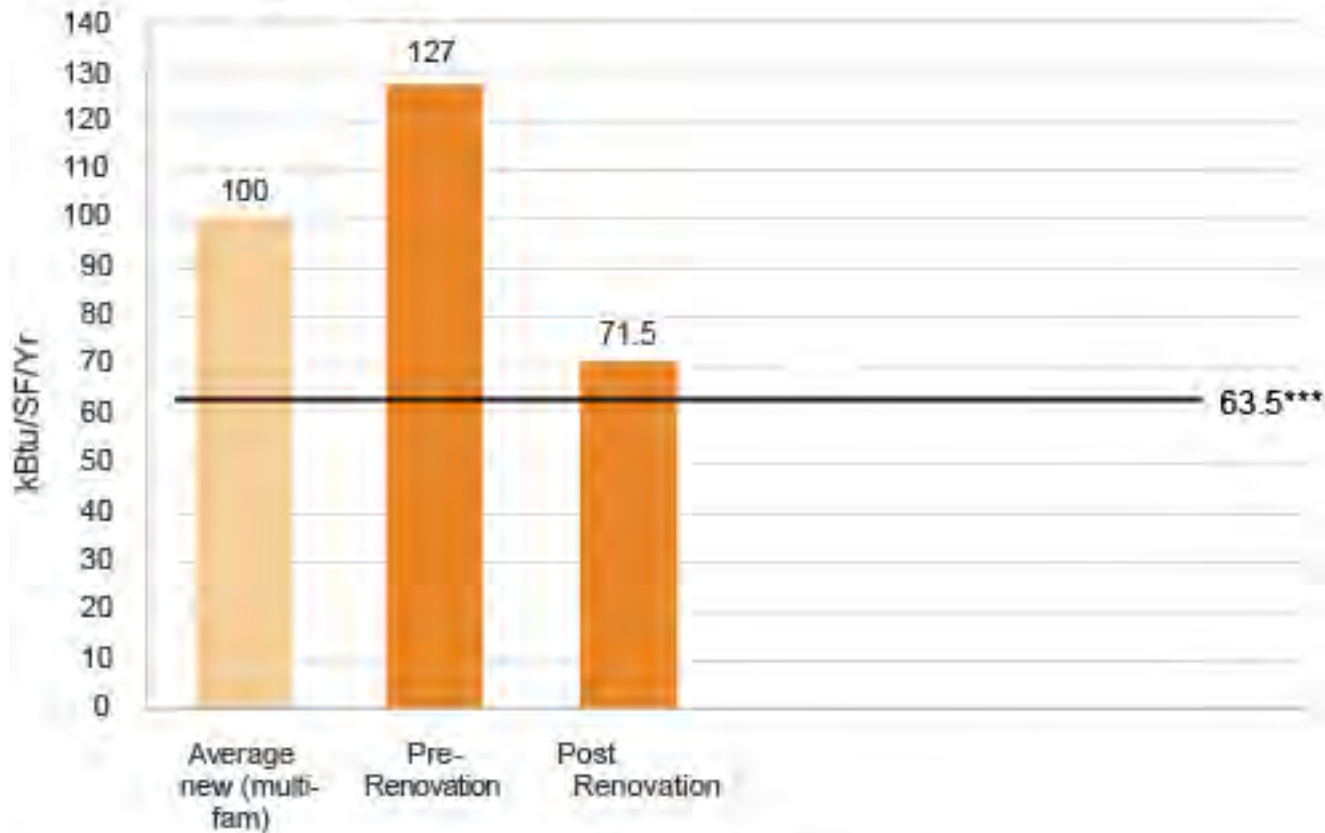
Annual Energy Intensity Omness Plaza Apartments

**Average energy intensity (multi-family) - 100 kBtu/ sf-yr
Based on The Weidt Group multi-family housing modeling code estimate.
***MN 2030 Challenge Target for 2005-2009

44% reduction in energy use

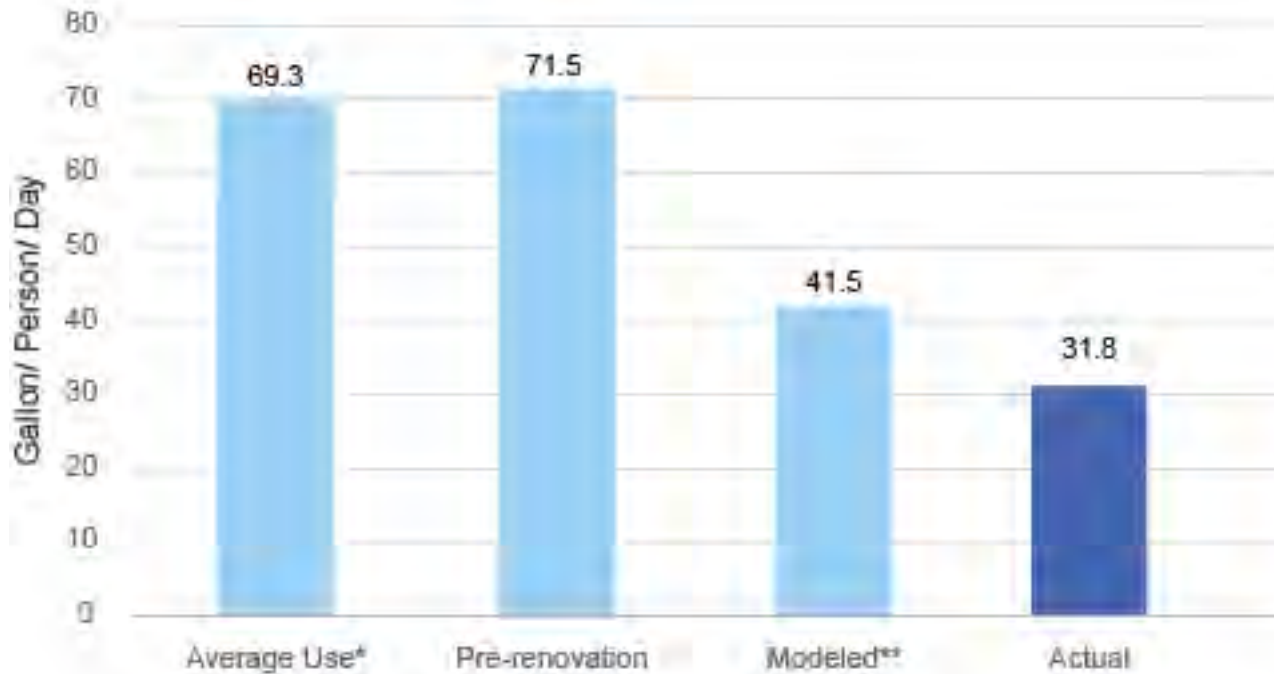
Indoor Water Use Ormess Plaza Apartments

54% less water use per person
