Home Performance Diagnostics – Extreme Peeling Paint Case Study

Sam Greene

Residential Science Resources

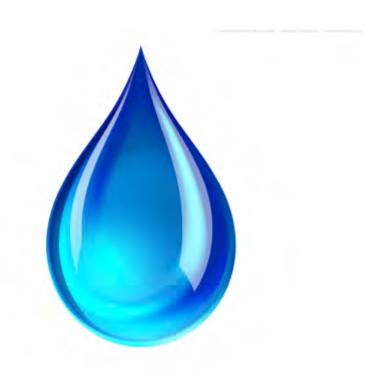
Paint does not adhere to...

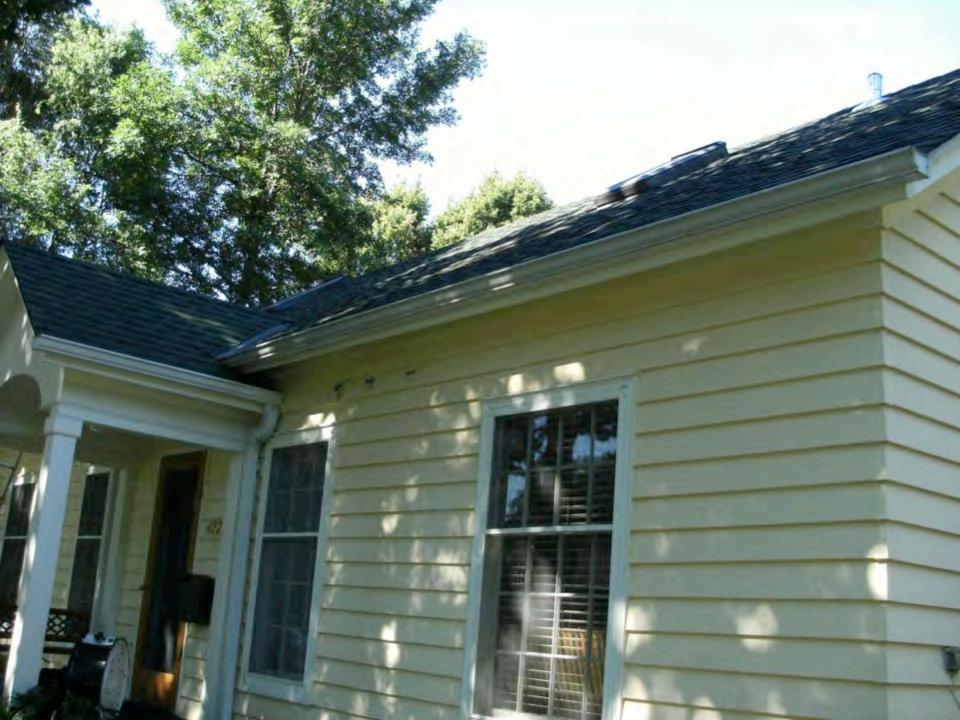
- **2010 2011?** Exterior paint applied to entire exterior, including soffit, fascia, etc. Paint peels within 6 months of being applied, paint chip tests by manufacturer reveal no paint failure, primarily no adhesion due to moisture in surface.
