VERIFIEDGREEN

Assessment and Strategy Development

Duluth 2010

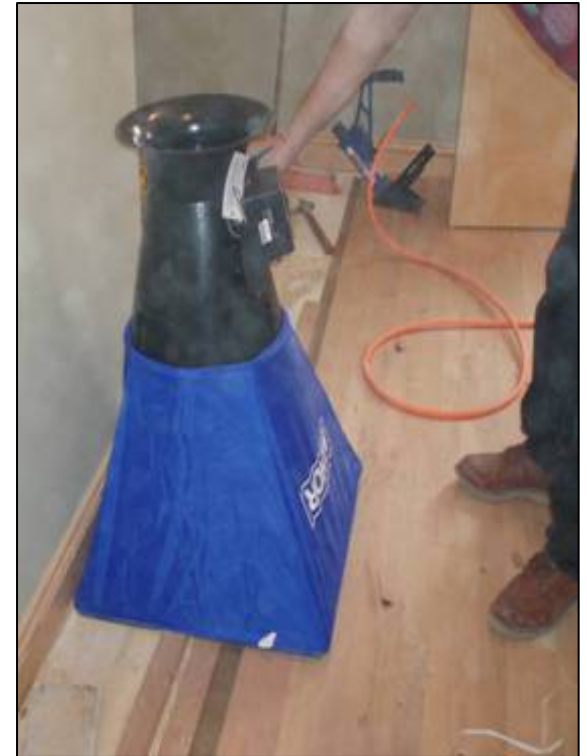
- The blometer test
 - Measuring cfm of exhaust
 - Impact on durability to remove moisture
 - Get what you paid for
 - Causes: Kinks, obstructions, faulty motors, to much restriction

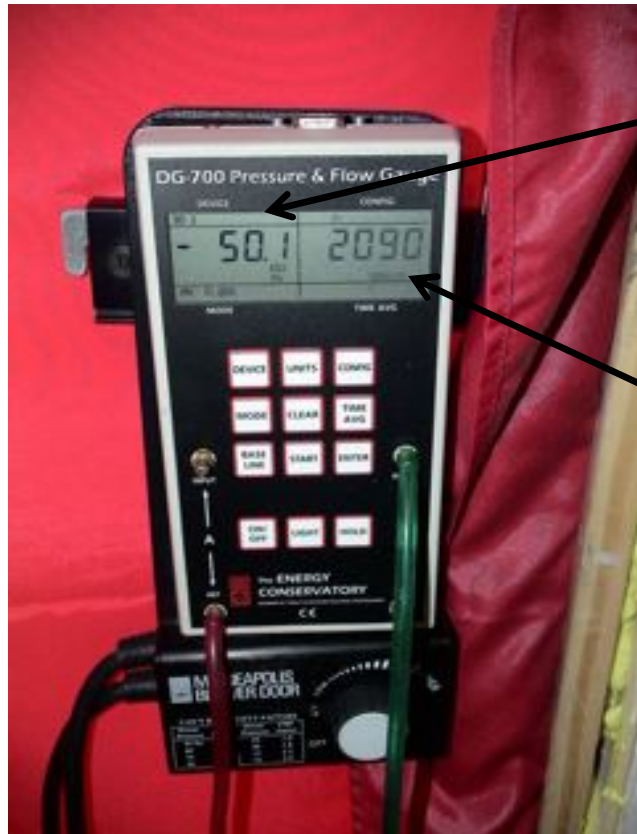
Blower Door Test

Depressurization levels

Air infiltration rate

- Depressurize the home to -50 Pascals
- Equal pressure on all sides of the home
- Air exchange is measured in ACH, CFM or CFM per SF

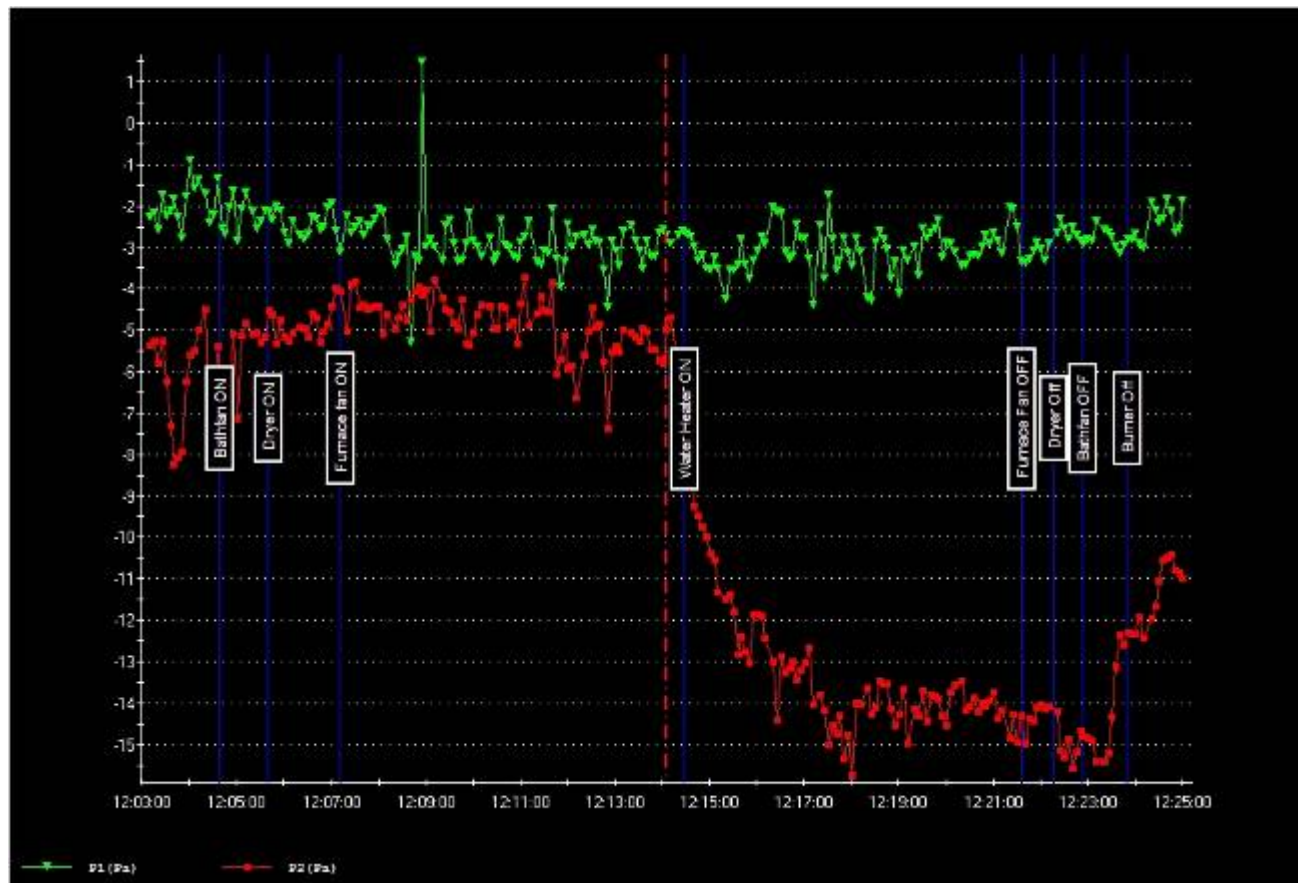
Spillage Test results

- How is it tested
 - Creating a worst case scenario with exhaust devices
 - Measuring the flow of flue gas before during and during worst-case event
 - Flow of flu-gas must remain positive throughout the test
 - Levels lower than 2 pascals suggest a risk for backdrafting
